ARTICLE

GALVANIZING HSS

by Jeffrey A. Packer
Bahen/Tanenbaum Professor of Civil
Engineering, University of Toronto,
Ontario, Canada

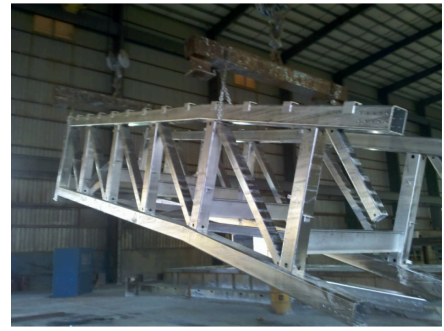
Figure 1: Segment of a HSS pedestrian bridge truss, after hot-dip galvanizing (Photo courtesy of American Galvanizers Association)

AISC 360-16 Section B3.13 (AISC, 2016) notes that corrosion of steel components must be addressed where corrosion could impair the strength or serviceability of a structure. Painting, galvanizing and metalizing are popular coating systems used to inhibit corrosion. Hot-dip galvanizing currently represents one of the most effective and economical methods for protecting steel components against corrosion (Figure 1).

For hot-dip galvanizing, holes to allow for filling, venting and drainage are necessary (see Figure 1), and adequate sizing minimizes differential thermal stresses experienced by the structural component during galvanizing. It is not an option to leave a hollow section member sealed during hot-dip galvanizing as there is a high risk of bursting the HSS. Consequently, the inside surfaces of the HSS will also be galvanized. Vent holes with a minimum diameter of 1/2 in. and drain holes with a diameter of 1 in. are recommended. It has been found that the presence of vent and drainage holes in HSS trusses, such as at the ends of branch members (see Figure 1), does not have a significant effect on the HSS connection resistance (Serrano et al., 2019).

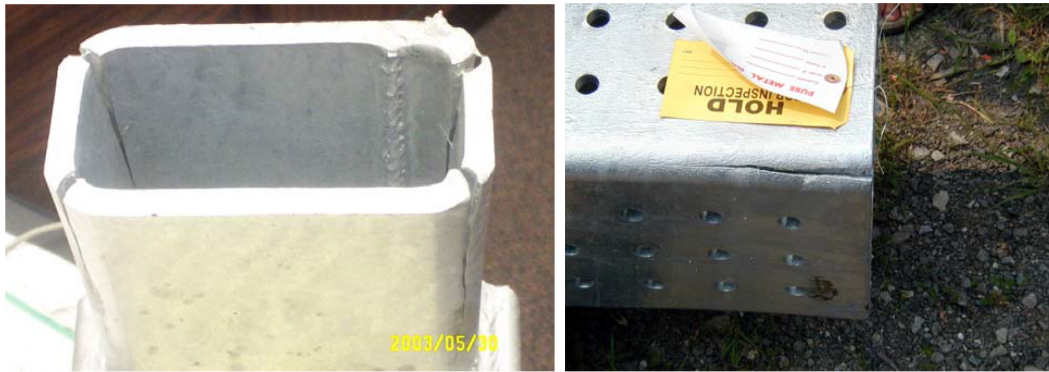
Figure 2: Examples of corner cracking in square and rectangular HSS, during hot-dip galvanizing

The temperature of a galvanizing bath is very similar to that specified for A1085 Supplementary Requirement S1 for heat-treatment (ASTM, 2015), so stress relief will occur. This should be borne in mind if one is hot-dip galvanizing cold-bent HSS members, for example, as pieces may distort from their bent shape due to stress relief. With galvanizing, the stress relief is very rapid and it occurs in the presence of a liquid metal which typically includes certain additives that exacerbate the situation, as noted above. The heavily cold-worked corners of square and rectangular HSS have a very high level of residual stress and all conditions may exist to induce liquid metal embrittlement of the corners (Packer et al., 2010a; Sun and Ma, 2019), such as shown in Figure 2. Thick-walled, square and rectangular HSS with an open end to the member are most at risk of corner cracking during hot-dip galvanizing (Sun and Packer, 2019).

The galvanizing standard A143 (ASTM, 2020) states that “a cold bending radius of three times the section thickness ... will ordinarily ensure satisfactory properties in the final product.” Although the outside corner radius of A1065 (ASTM, 2018) is specified to be three times the wall thickness ($3t$) or greater, this is the *upper* corner radius limit for square and rectangular HSS to A500 and A1085. In fact, the outside corner radius of A500 and A1085 averages $2t$ in practice and this geometry is used for determination of their section properties. Thus, all square and rectangular A500 and A1085 HSS produced in North America are potentially prone to embrittlement and corner cracking during hot-dip galvanizing. Kinstler (2005) pointed out that “... the amount of cold work, as measured by the bending radius, is the most important single factor to consider when there is concern for brittle-type failure of steel galvanized after cold working.”

A visual inspection of the corners of square and rectangular HSS, at the member ends, is prudent after galvanizing. However, one must bear in mind that small “invisible” cracks may be present but be masked by filling with liquid zinc. Such cracks may become a problem during the service life of the structure, particularly if fatigue loading occurs. Round HSS, which does not have zones of severe cold forming like rectangular HSS, does not have any concerns with cracking during hot-dip galvanizing. Multi-sided cold-formed hollow sections, such as used for high mast illumination poles (HMIPs), on the other hand, have been found to occasionally crack during hot-dip galvanizing (Nasouri et al., 2019). Metalizing is another form of coating structural steel for corrosion control, providing protection for significantly longer times than just paint, but it is more expensive than galvanizing. In this process, zinc or aluminum wire is continuously melted and, propelled by compressed air, is sprayed onto the steelwork forming both a barrier and a galvanic coating. The steel remains relatively cool (around 250 to 300 °F) so there is virtually no risk of heat distortion or liquid metal embrittlement.
